REPORT BMS40

Structural Properties of a Wall  
Construction of "Knap Concrete  
Wall Units" Sponsored by  
Knap America Inc.

HERBERT L. WHITTEMORE,  
AMBROSE H. STANG, *and*  
CYRUS C. FISHBURN

ISSUED FEBRUARY 21, 1940

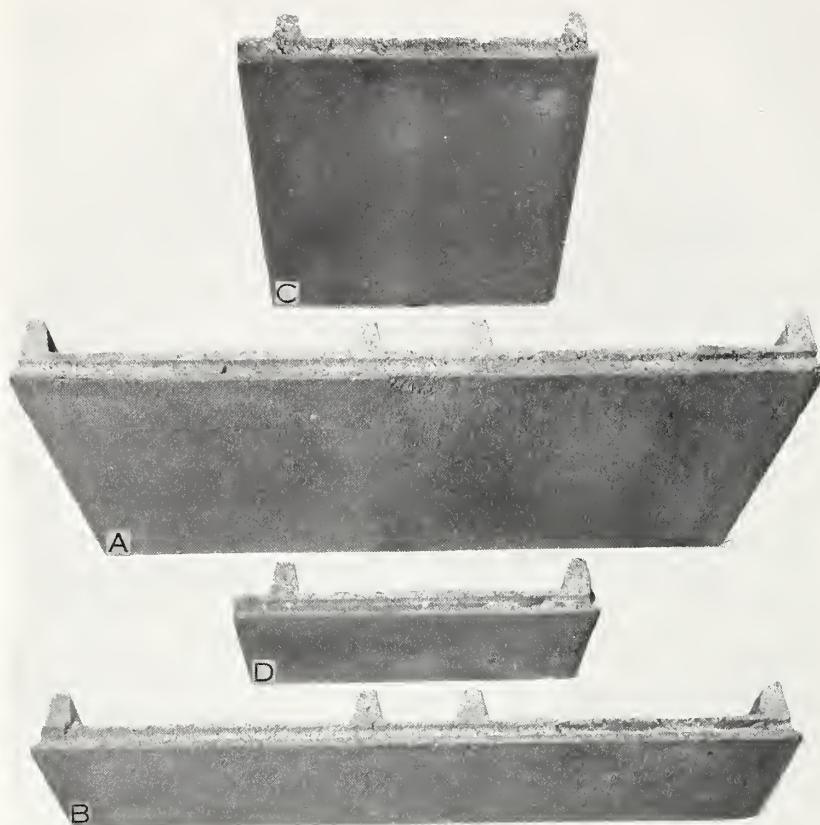
FIGURE 1.—Concrete units.  
A, standard unit; B, half-height unit; C,  
half-width unit; D, quarter unit.

Four sizes of units are shown in figure 1; details of standard unit, A, and half-height unit, B, are shown in figure 2; with half-height unit, C, and quarter unit, D, shown in figure 3. The size of the pieces of the mesh reinforcement for the standard unit, A, was 1 ft 8 3/4 in. by 3 ft 6 3/4 in. The mesh for the other units was cut from like pieces.

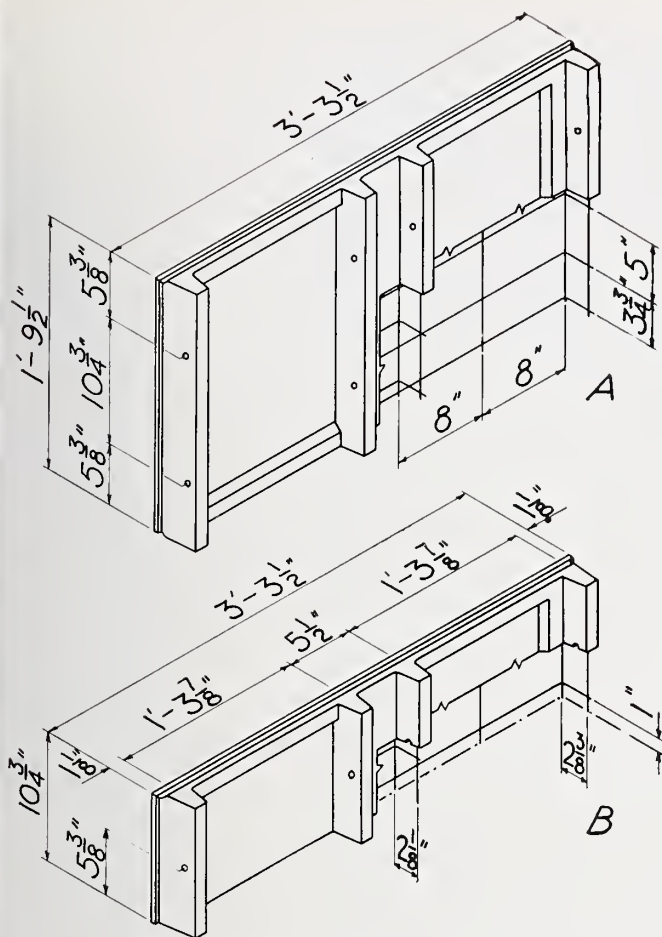
FIGURE 2.—Details of concrete units.

A, standard unit; B, half-height unit.

All units were made in the same mold by the use of removable metal stops. There was a semicircular groove, 1/2-in. diam, along each edge of the standard unit. The lip of the grooves on the inner surface projected 1/8 in. beyond the lip on the outer surface. The edges of the other units were grooved except those edges in contact with a stop in the mold. There were holes having a diam of 1/2 in. through the ribs of the units, 1 in. from the edge of the ribs. The physical properties of two standard units were determined. The absorption for 24-hr cold total immersion was 4.6 percent of the dry weight of the unit, or 6.4 lb of water per cubic foot of concrete. The average weight was 142 lb/ft<sup>3</sup> of dry concrete. The dry weight of a standard unit was 95.6 lb, of a half-height unit 45.6 lb, of a half-width unit 46.9 lb, and of a quarter unit 23.7 lb.

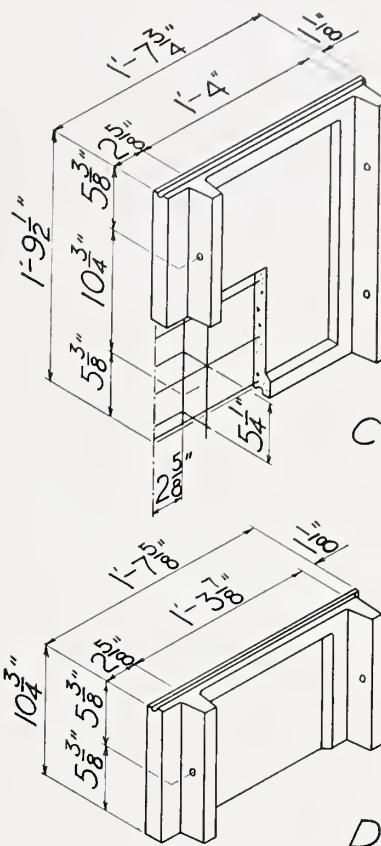
FIGURE 3.—Details of concrete units.

C, half-width unit; D, quarter unit.

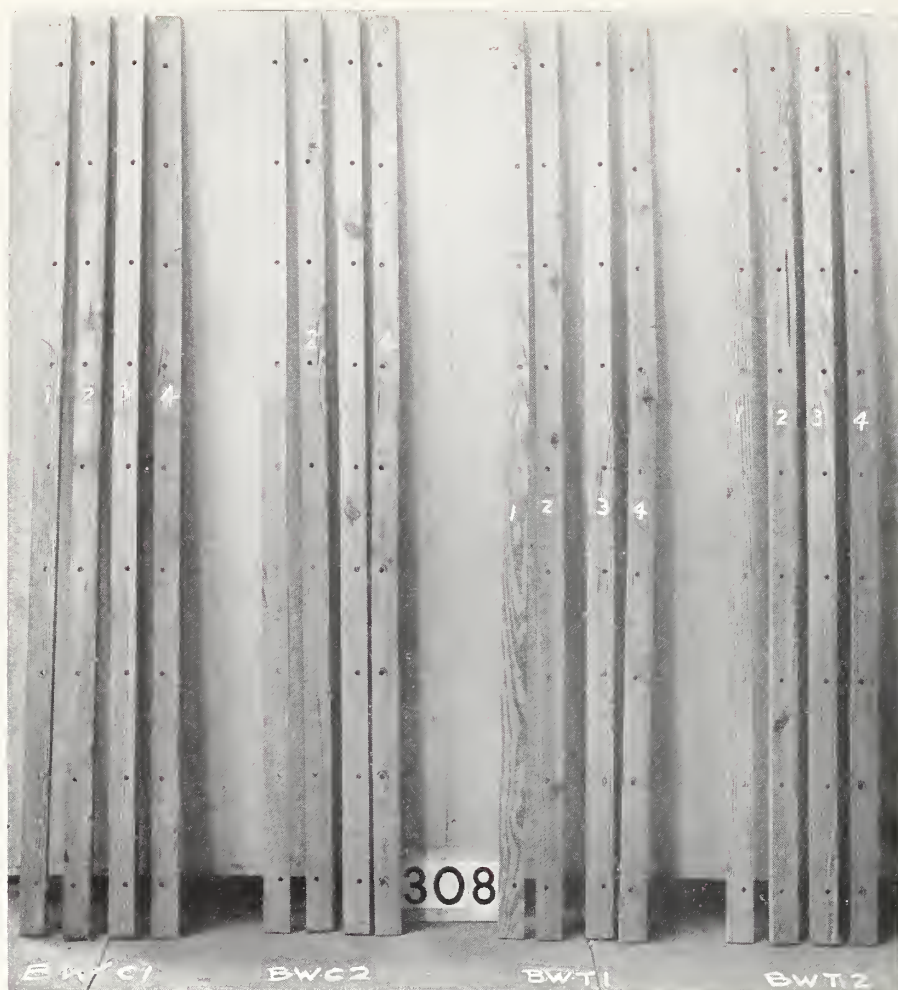
FIGURE 4.—*Typical wood splines.*

Wood splines.—Longleaf southern pine, merchantable grade, identified by the Forest Products Laboratory as southern yellow pine. Typical splines are shown in figure 4.

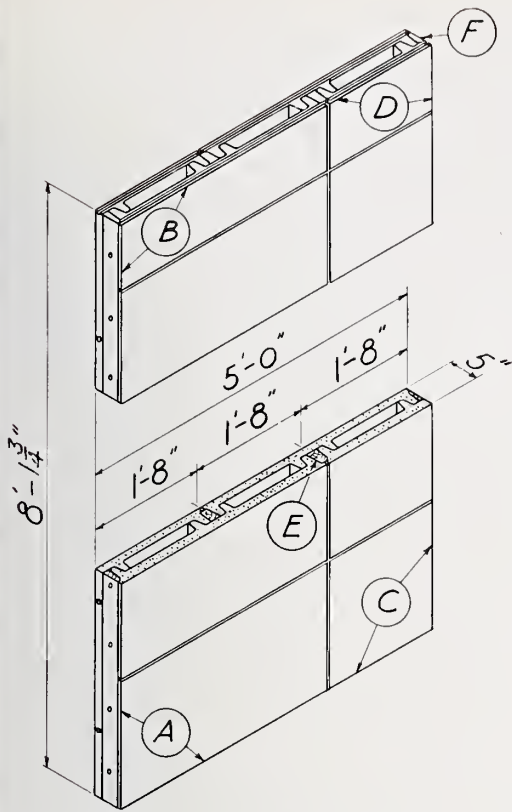
FIGURE 5.—*Four-foot wall specimen BW.*

*A*, standard unit; *B*, half-height unit; *C*, half-width unit; *D*, quarter unit; *E*, spline; *F*, half spline.

(1) *Four-foot wall specimens.*—The 4-ft wall specimens, shown in figure 5, were 8 ft  $1\frac{3}{4}$  in. high, 5 ft 0 in. wide, and 5 in. thick. There were four courses consisting of standard units, A, and half-width units, C, and one course of half-height units, B, and a quarter unit, D, with a continuous vertical joint in each face of the specimen. Each horizontal joint was at mid-height of the opposite full-height units in the other face of the specimen. Each vertical joint was at midwidth of the opposite full-width units in the other face of the specimen. The top course of one face consisted of one half-height unit, B, and one quarter unit, D, and the bottom course of the other face consisted of two like units. There was a vertical row of half-width units in each face of the wall, and the vertical joint in one face was 1 ft 8 in. from the vertical joint in the other face. A

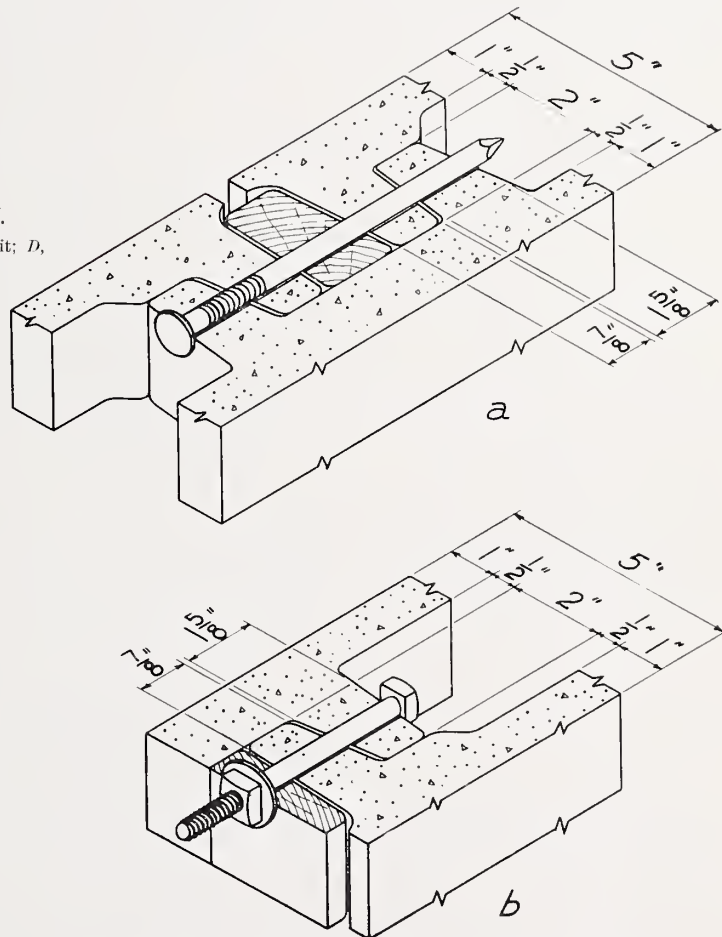
FIGURE 6.—Fastening concrete units to wood splines.

*a*, pin through ribs and spline at inner ribs; *b*, bolt through ribs and half spline at edge ribs.

wood spline, *E*,  $2\frac{3}{4}$  in. wide,  $1\frac{1}{2}$  in. thick at one edge, and beveled on both sides to a thickness of  $1\frac{1}{8}$  in. at the other edge, 8 ft  $1\frac{3}{4}$  in. long, was pinned to the ribs of the units at the vertical joints; the pins passing through the holes in the ribs and through  $\frac{1}{2}$ -in. holes spaced  $10\frac{3}{4}$  in. on centers in the splines. A half spline, *F*,  $2\frac{3}{4}$  in. wide,  $\frac{7}{8}$  in. thick at one edge, and beveled on one side to a thickness of  $\frac{5}{8}$  in. at the other edge, 8 ft  $1\frac{3}{4}$  in. long, was at each edge of the specimen and was fastened to the ribs of the units by bolts passing through the holes in the ribs and through  $\frac{1}{2}$ -in. holes spaced  $10\frac{3}{4}$  in. on centers in the half splines. There was a washer under the nut on each bolt. The pinned and bolted connections are shown in figure 6.

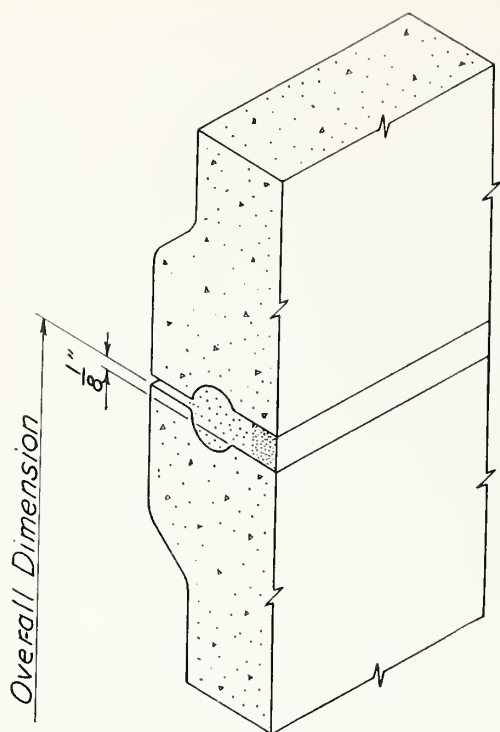
FIGURE 7.—Mortar joint between units.

were pointed with "Brixment" mortar. The joints in the specimens in batch 1 were raked but not pointed. A pointed joint is shown in figure 7.

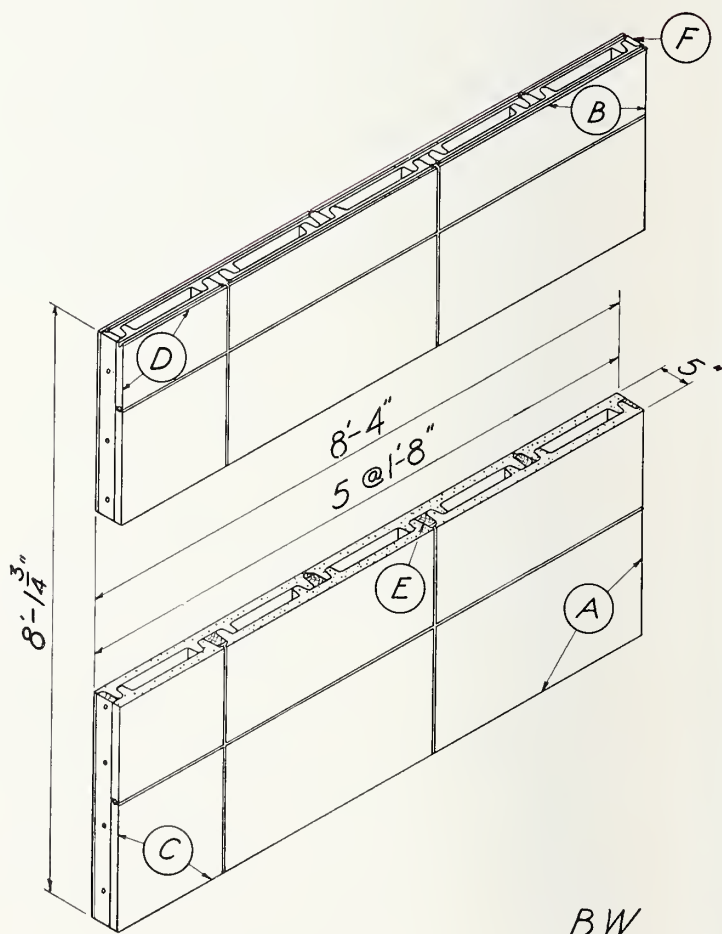
FIGURE 8.—Eight-foot wall specimen BW.  
A, standard unit; B, half-height unit; C, half-width unit;  
D, quarter unit; E, spline; F, half spline.

(2) *Eight-foot wall specimens.*—The 8-ft wall specimens shown in figure 8 were 8 ft  $1\frac{3}{4}$  in. high, 8 ft. 4 in. wide, and 5 in. thick. The specimens were similar to the 4-ft specimens and consisted of two standard units, *A*, and a half-width unit, *C*, in each course. The top course of one face and the bottom course of the other face consisted of two half-height units, *B*, and a quarter unit, *D*. There were four splines, *E*, at the vertical joints between the

units, and two half splines,  $F$ , at the edges of the specimen.

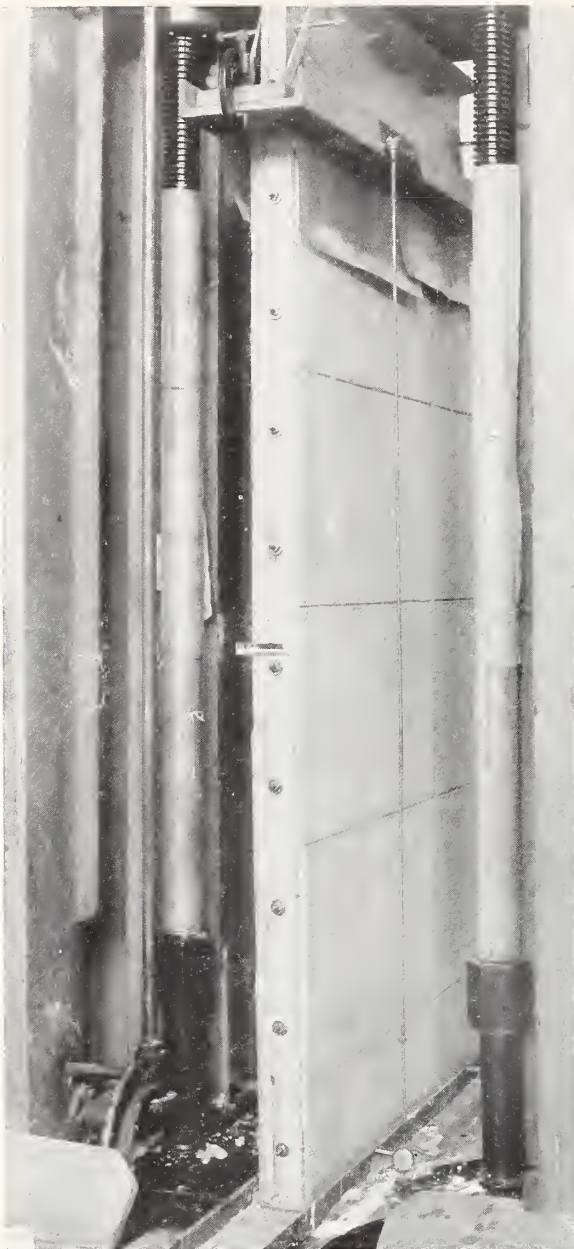
FIGURE 9.—Wall specimen BW-C1 under compressive load.

Wall specimen *BW-C1* under compressive load is shown in figure 9. The results for specimens *BW-C1*, *C2*, and *C3* are shown in table 4 and in figures 10 and 11.

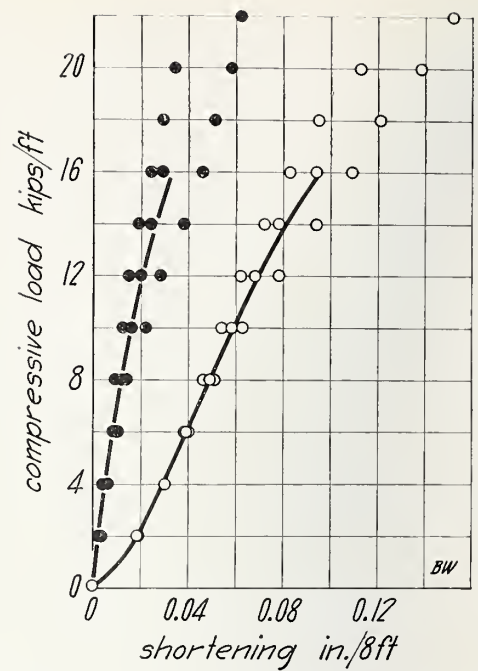
FIGURE 10.—Compressive load on wall BW.

Load-shortening (open circles) and load-set (solid circles) results for specimens BW-C1, C2, and C3. The load was applied 1.67 in. (one-third the thickness) from the inside face. The loads are in kips per foot of actual width of specimen.

The shortenings and sets shown in figure 10 for a height of 8 ft were computed from the values obtained from the compressometer readings. The gage length of the compressometers was 8 ft 2 in.

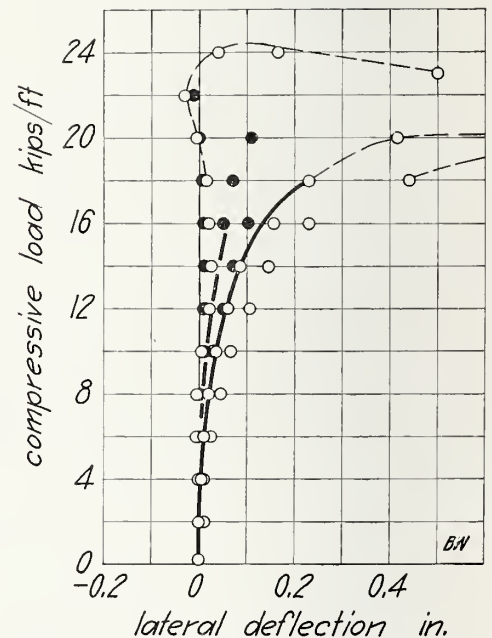
FIGURE 11.—Compressive load on wall BW.

Load-lateral deflection (open circles) and load-lateral set (solid circles) results for specimens BW-C1, C2, and C3. The load was applied 1.67 in. (one-third the thickness) from the inside face. The deflections and sets are for a gage length of 7 ft 11 in., the gage length of the deflectometers.

The lateral deflections shown in figure 11 were plotted to the right of the vertical axis for deflections of the specimens toward the "outside" face (positive deflection) and to the left

for deflections toward the "inside" face (negative deflection).

For specimens *C1* and *C3* the deflections and sets were positive. For specimen *C2* they were very small, sometimes positive, sometimes negative, under loads less than about 23 kips/ft. Under greater loads the deflections were positive and increased markedly with little change in the load.

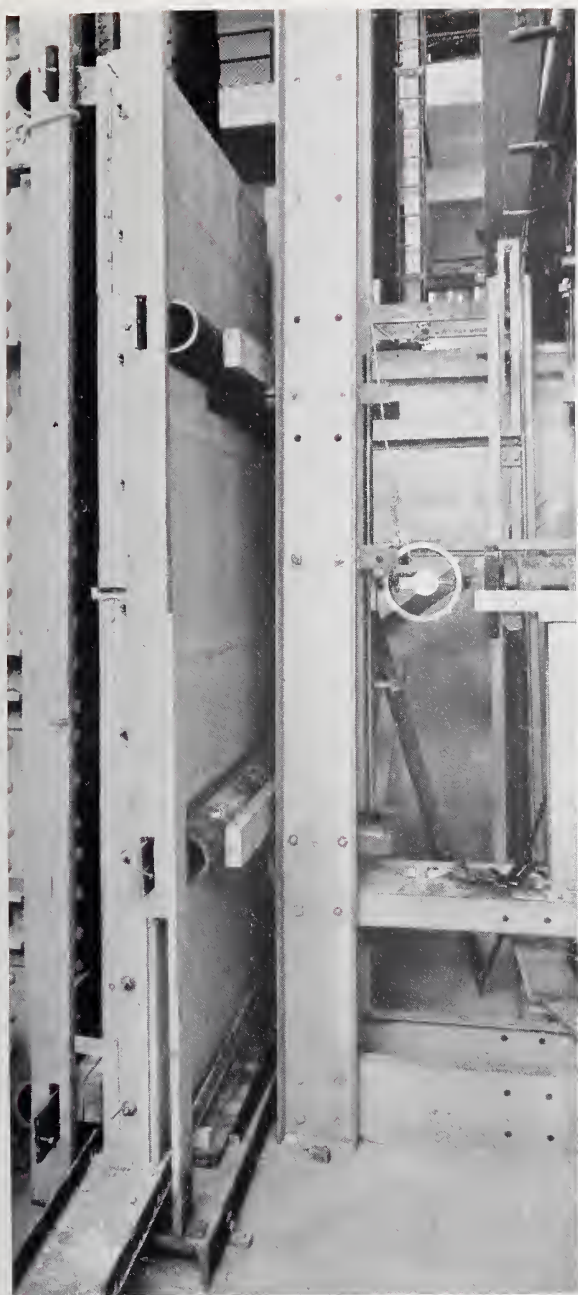
FIGURE 12.—Wall specimen BW-T2 under transverse load.

Wall specimen BW-T2 under transverse load is shown in figure 12. The results for specimens BW-T1, T2, and T3 are given in tables 4 and 5 and in figure 13.

At the maximum load each specimen failed by rupture of all, or all but one, of the wood splines and half splines about 8 in. above midspan. Rupture in the bond between the

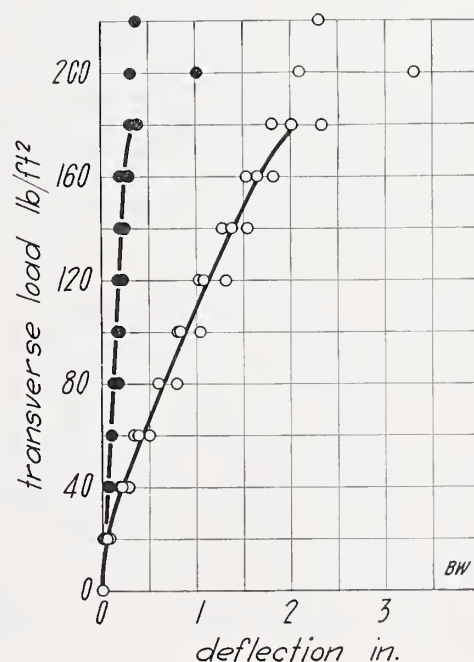
FIGURE 13.—Transverse load on wall BW.

Load-deflection (open circles) and load-set (solid circles) results for specimens BW-T1, T2, and T3 on the span 7 ft 6 in.

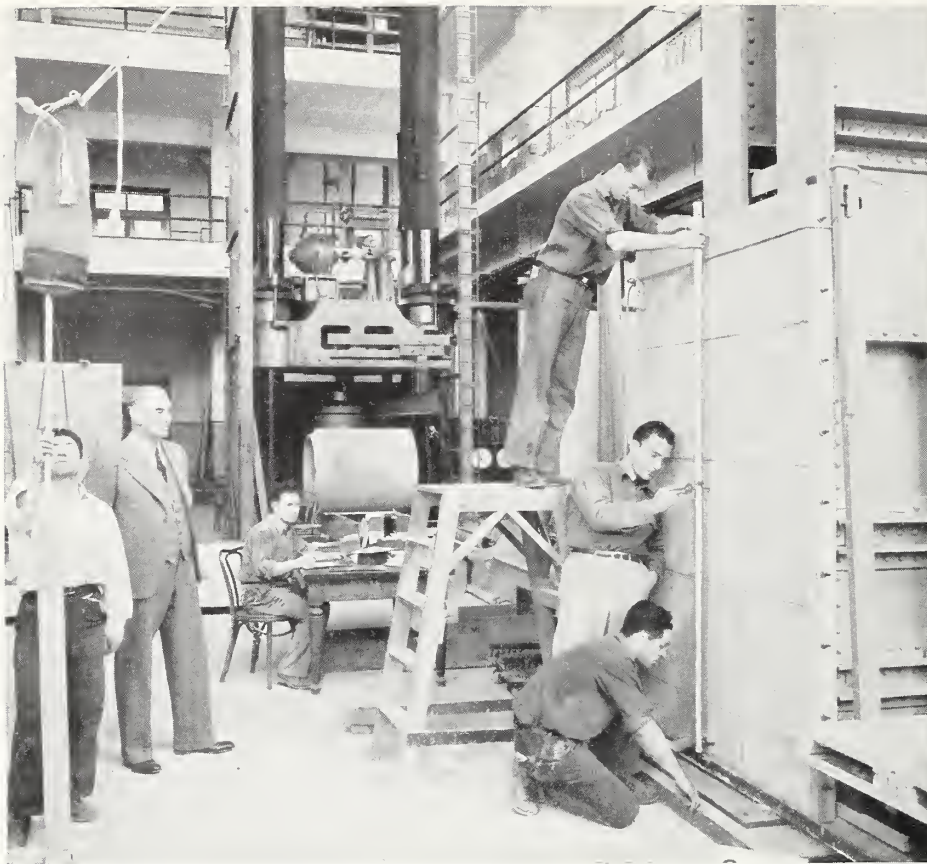
FIGURE 14.—Wall specimen BW-I2 during the impact test.

Wall specimen BW-I2 during the impact test is shown in figure 14. The results are shown in tables 4 and 6 and in figure 15 for wall specimens BW-I1, I2, and I3.

The impact loads were applied to the center of the specimens, the sandbag striking between the ribs of a unit. After a drop of 10 ft most of the horizontal joints had cracked but no wood splines had ruptured.

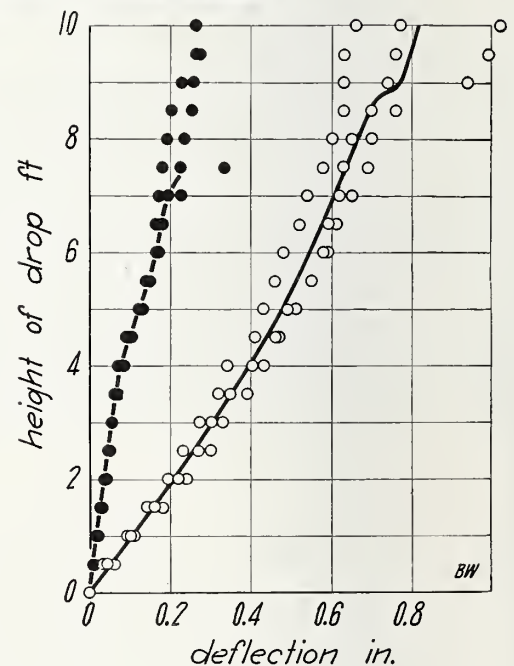
FIGURE 15.—Impact load on wall BW.

Load-deflection (open circles) and load-set (solid circles) results for specimens BW-I1, I2, and I3 on the span 7 ft 6 in.

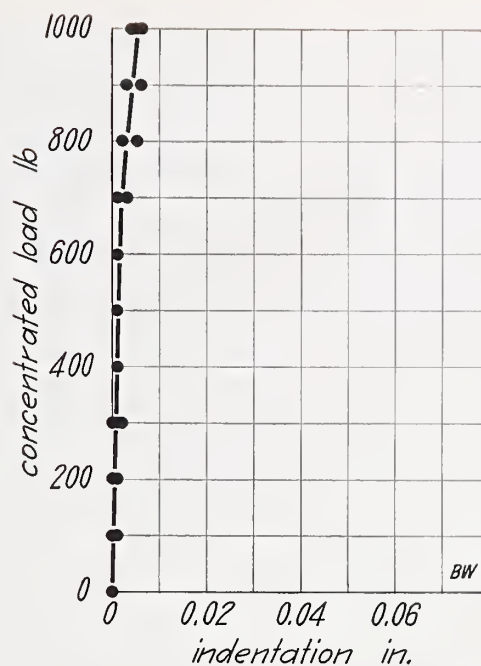
FIGURE 17.—Concentrated load on wall *BW*.  
Load-indentation results for specimens *BW-P1*, *P2*, and *P3*.

Wall specimen *BW-P1* under concentrated load is shown in figure 16. The results for specimens *BW-P1*, *P2*, and *P3* are shown in table 4 and in figure 17.

The concentrated loads were applied midway between the ribs of a unit, from 3 to 4½ ft from the bottom end of the specimens. After a load of 1,000 lb had been applied, the indentation in specimen *P1* was 0.006 in.; in specimen *P2*, 0.005 in.; and in specimen *P3*, 0.004 in.; and no other effect was observed.

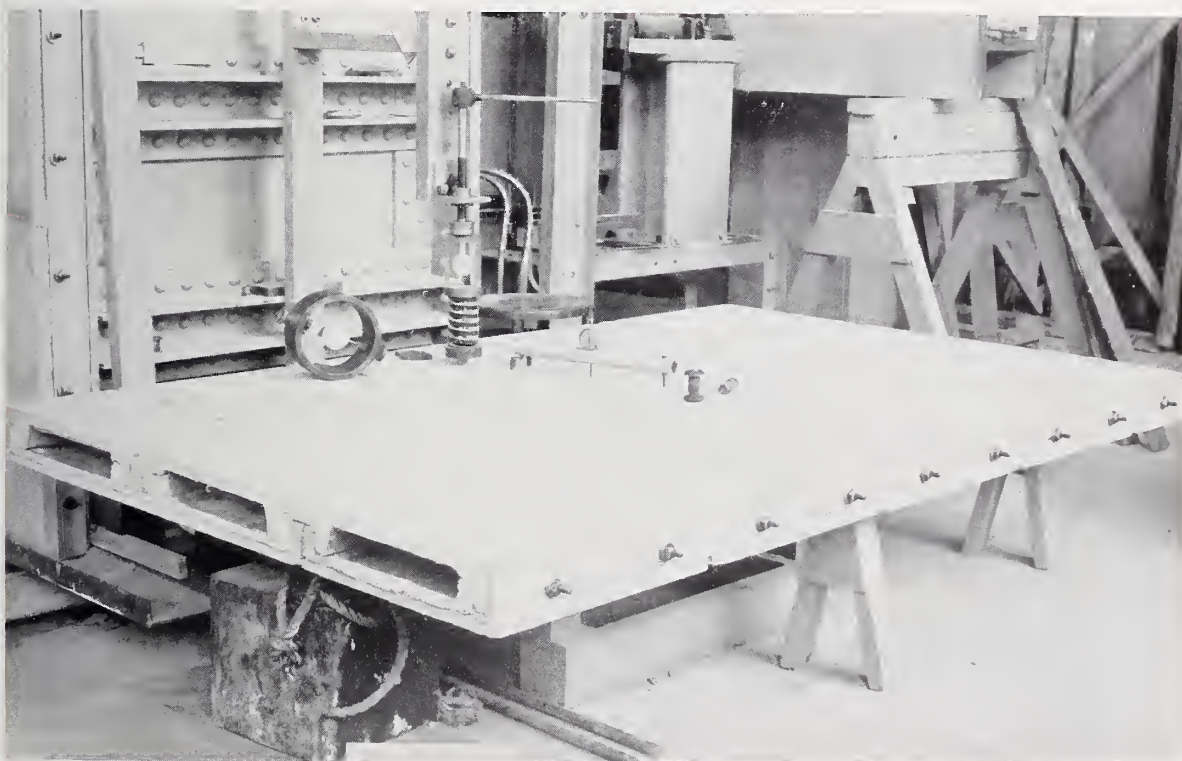
FIGURE 16.—Wall specimen *BW-P1* under concentrated load.

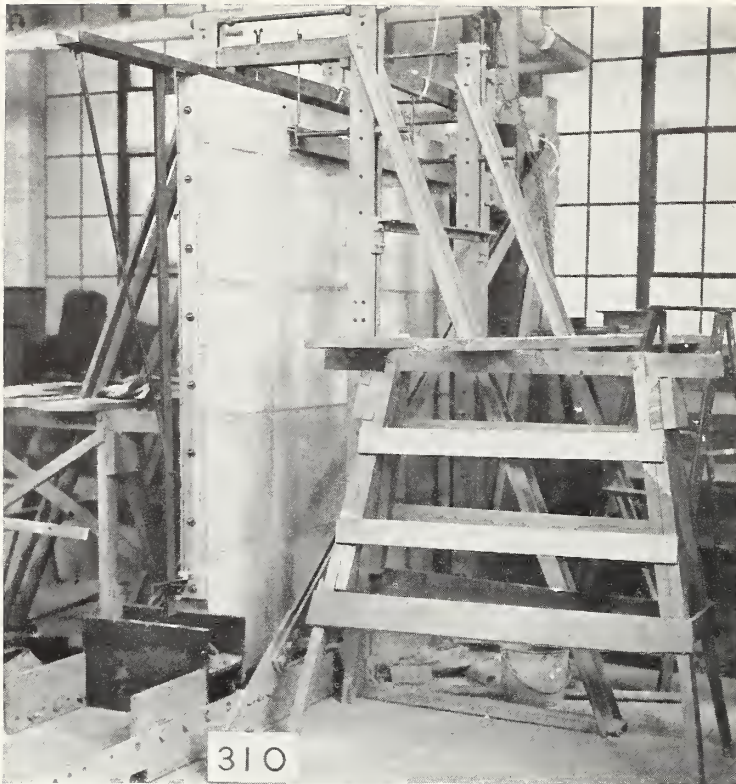
FIGURE 18.—Wall specimen BW-R1 under racking load.

Wall specimen *BW-R1* under racking load is shown in figure 18. The results for specimens

For each of the specimens all or nearly all of the joints in both faces cracked in the bond between the mortar and the units, and most of the units broke. The first crack in the mortar occurred in a vertical joint at a load of 1.5 kips/ft. Under this load the deformation of specimen R1 was 0.070 in.; of specimen R2, 0.019 in.; and of specimen R3, 0.022 in. The units began to break at loads of 3.3, 3.0, and 3.0 kips/ft, respectively. Under the maximum load each of the specimens failed by crushing of the units along the loaded edge and buckling of the middle units of the top course.

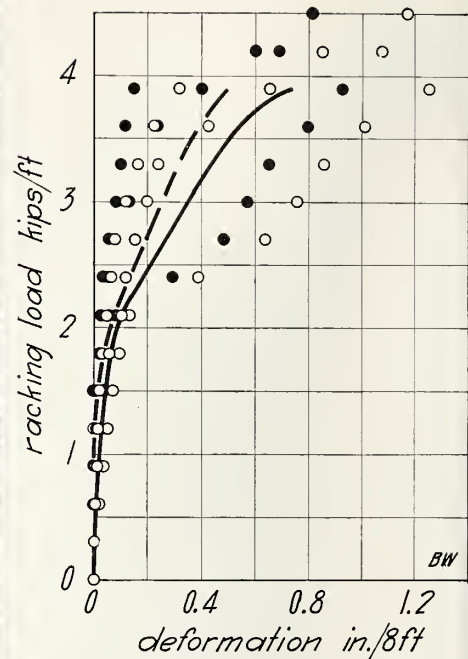
FIGURE 19.—Racking load on wall BW.

Load-deformation (open circles) and load-set (solid circles) results for specimens BW-R1, R2, and R3. The loads are in kips per foot of actual width of specimen.

The deformations and sets shown in figure 19 for a height of 8 ft were computed from the deformer readings. The gage length of the deformer was 6 ft 6 in.
